**SAS Superstructure**

Daily Diary Report by Bid Item

Contract No.: 04-0120F4

Diary #: 761 Const Calendar Day: 225 Date: 15-Jan-2013 Tuesday

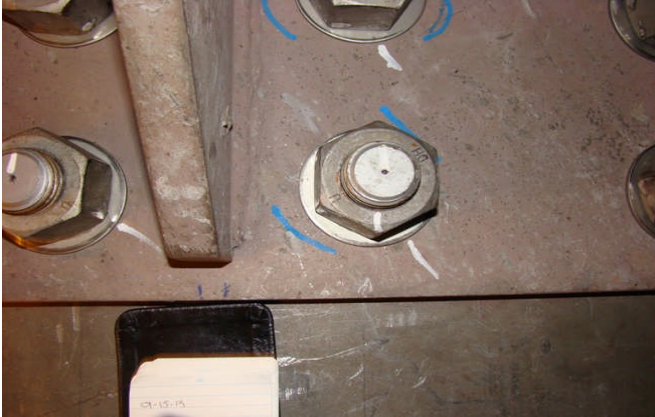
While attempting to tension the bolts to a 1/2 turn a few bolts rolled even though there was an ironworker in the pipe using a knocker wrench to hold the bolt head. When this happened the ironworker tensioning the bolts would wait until the bolt "caught" or was "snug" and then watched the 1/2 turn marks on the hydraulic impact wrench before stopping. This occurrence cause some of the match marks to indicate that the 1/2 turn wasn't achieved. However it should be reiterated that myself and Brien watched the 1/2 turn.

Once the bolts on both restraint brackets were tensioned there were 6 of 20 bolts tested on the AE-South-Diaphragm B-East-Top restraint bracket. Similarly 9 of 20 bolts on the AE-North- Diaphragm B-East-Top restraint bracket were tested with the torque wrench set to 2400N-m. All of the bolts tested passed and a few after retightening. See photos below for more details on the matchmarks at these locations. It should be noted that care should be taken when applying tension to the A490 bolts and overstressing is a concern as well.

Tested bolts (blue marks) with the Smith Emery torque wrench where the matchmarks were not 1/2 turn due to the bolts rolling after snugging.

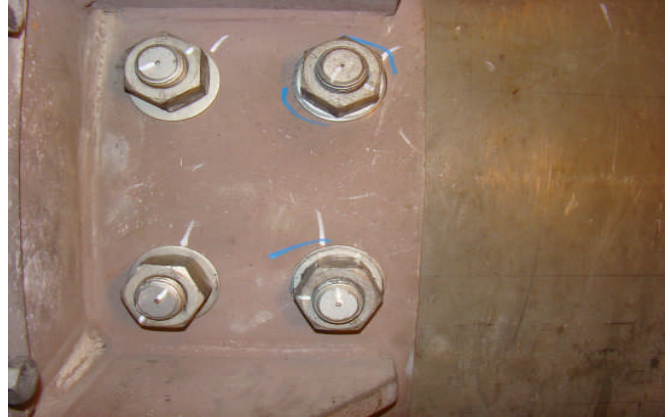
Match marks of the bolted restraint bracket at Hinge A pipe beam AE-North-Diaphragm B-Top-East where the bolts rolled after snugging.

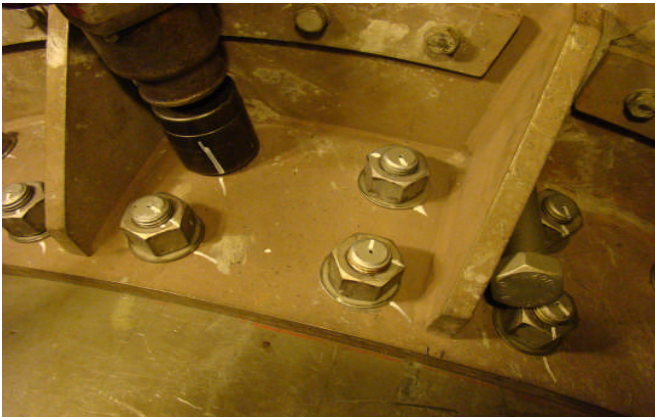
Myself and Smith Emery technician Brien Connolly were present at all times during the bolting operations of these first two pipe beam restraint brackets. The ironworkers were diligent about snugging the bolts from the center out to the ends. After this was done the 1/2 turn match mark was made on the bolt, nut, and steel ply.

Match marks of the first restraint bracket to be bolted at Hinge A pipe beam AE-South-Diaphragm B-Top-East where the bolts rolled after snugging.

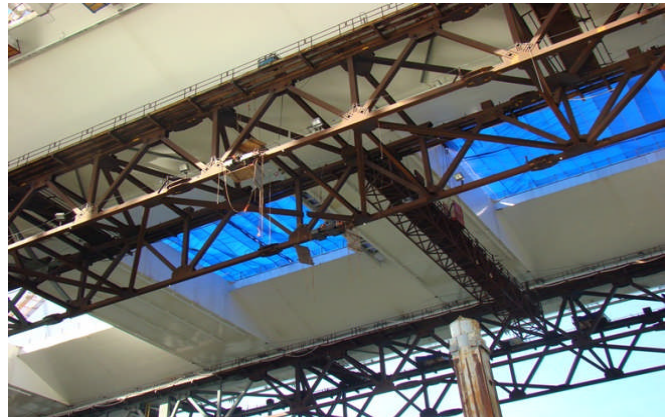
ABF ironworkers beginning to cut the cross braces of the E-Line truss with a jacking bracket to resist unexpected loads.
